**PASSEN INSPECTIONS AND
THERMAL IMAGING**

Inspection date: June 18, 2015 **Inspection time start/finish: 1:10/4:05pm**

Requested for:	George H. Ruth	Phone: 407.555.0714
Street:	714 Homerun Court	Phone: 407.
City/Zip:	Orlando, FL 32817	Email: thebambino@yahoo.com
Referred by or client of:		Phone: 407. Phone: 407. Email: .com

Inspections requested: Full home.

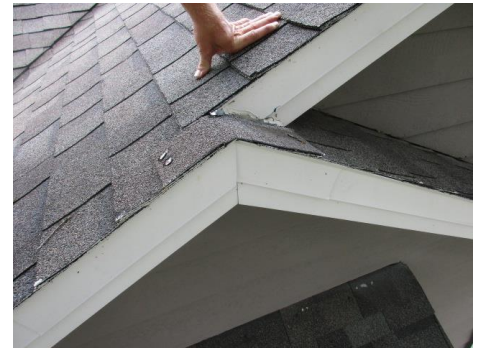
Rake ridge

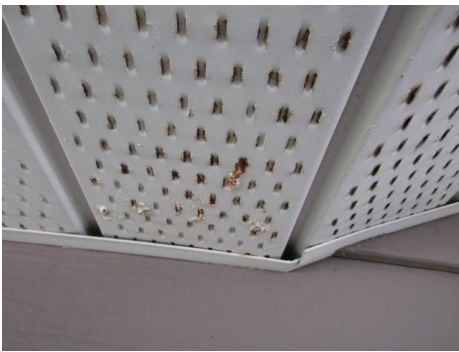
Corrosion under cut drip edge

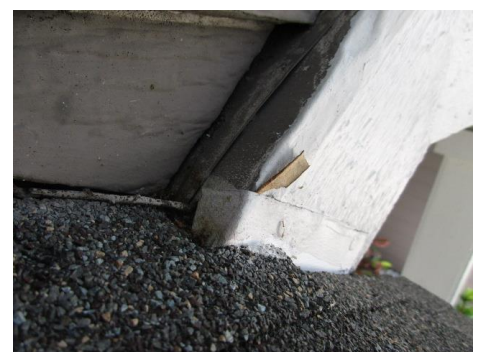
Flashing with reversed lap

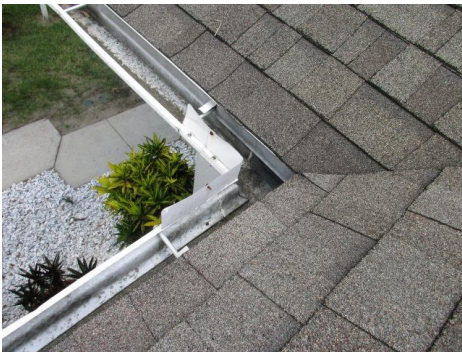
Gutter System	Impact damage noted throughout, repair as necessary. We recommend all guttering systems have splash blocks and/or extension pipes to direct water away from foundation. It has been our experience that splash back can occur with gutter damn installations causing water penetration under shingles.	FYI

Gutter dam

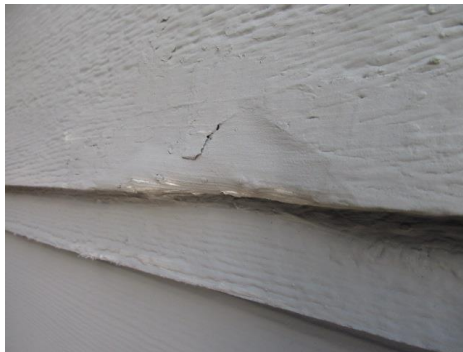
Concealed damage

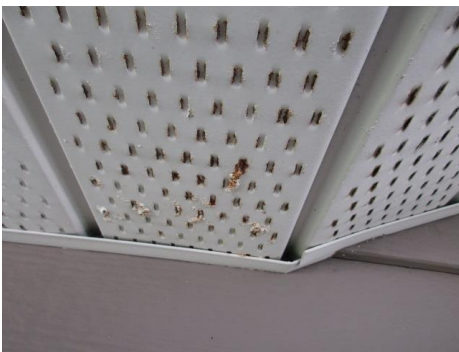
Fascia & Soffit	Corrosion noted on some soffit areas is an indication of previous leakage, monitor. One area is under the cupped area/cut drip edge in the left front, repair. Spray foam noted in right gable/soffit transition, most likely for exclusion work. Paint to inhibit UV damage. Repair/replace missing soffit panels in porch.	FYI Minor
Trim	Several areas of minor wood damage, repair as necessary. Some damage has been painted and concealed. Trim board at bottom of gable is unpainted on top, has unsealed butt joints, and has no flashing/sealant above. Horizontal butt joints vulnerable to moisture intrusion and damage. This can also provide conditions conducive to infestation. Flashing is a permanent repair, caulking may not be.	Minor
Windows & Doors	Exterior window/door frame caulking needs to be monitored/maintained on a yearly basis to prevent gapping and subsequent moisture intrusion. Keep all window sill cracks sealed to inhibit interior rebar corrosion and sill damage. Some windows have no weep holes allowing water to pond in tracks, repair. Security upgrade recommended on exterior outswinging doors to inhibit access to bolts of lockset and dead bolt.	Minor Security

Corrosion under cut drip edge

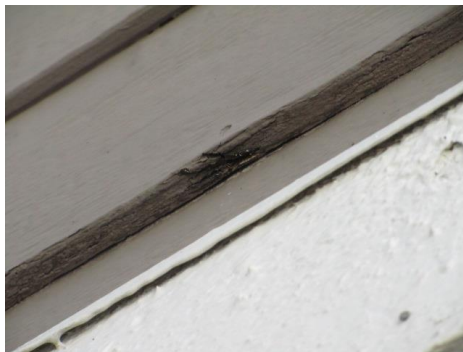
Wood damage

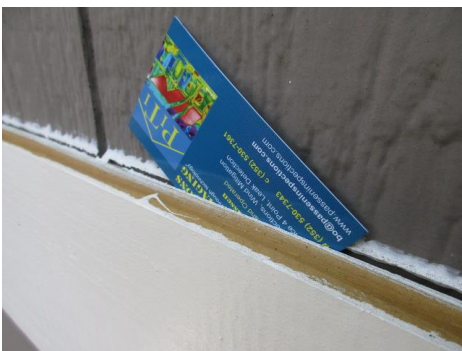
Unpainted, unflashed

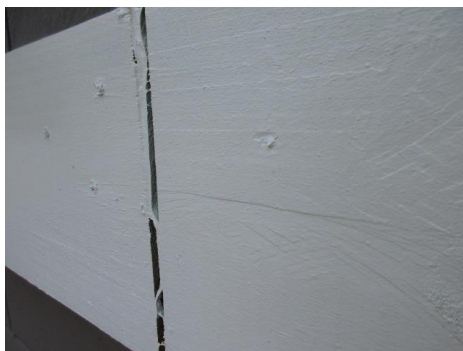
Butt joint

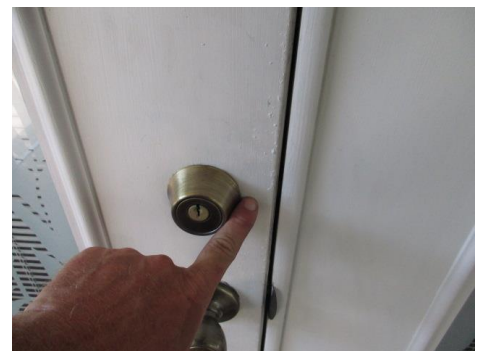
Outswinging door, security

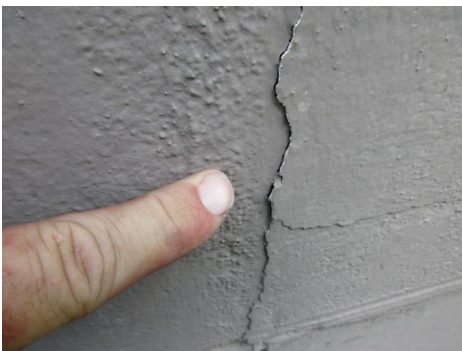
Crack at frame repair

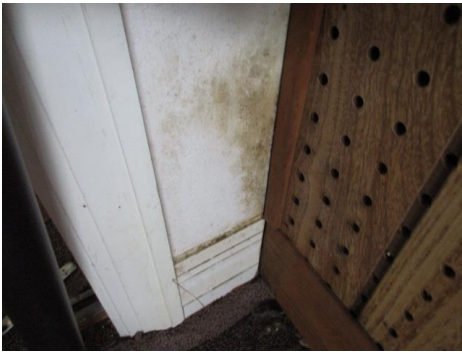
Moisture stains, garage near water heater

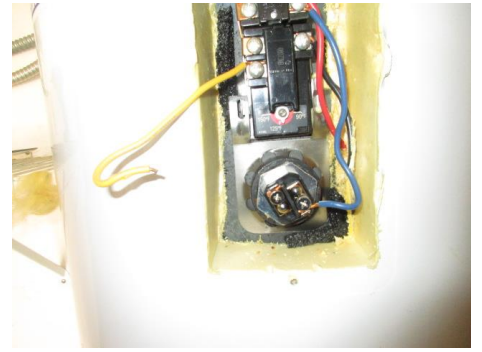
Damaged wire, prior to my repair

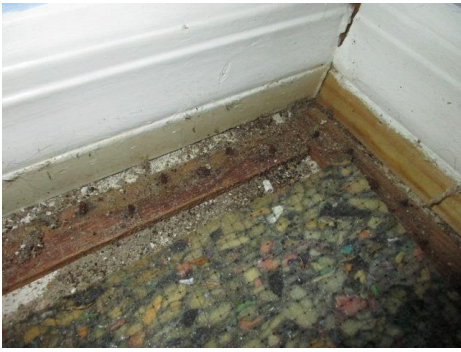
Moisture stains on tack strips

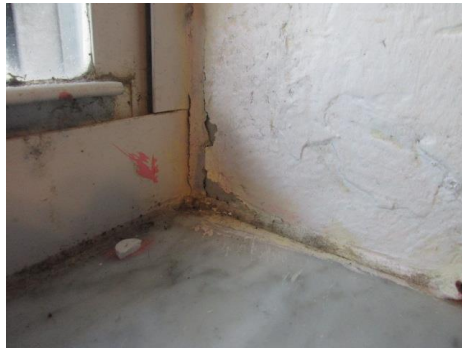
Moisture evidence on window

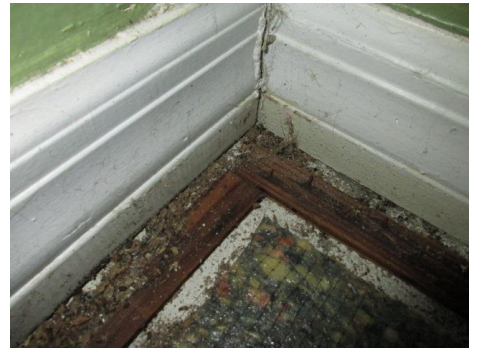
Moisture stains on tack strips

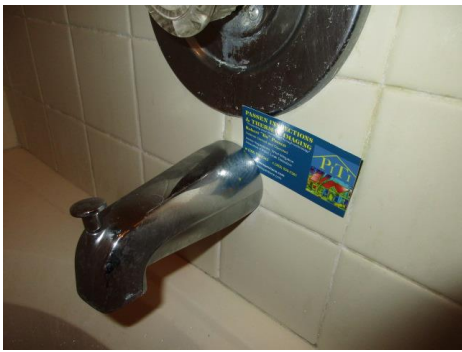
Seal

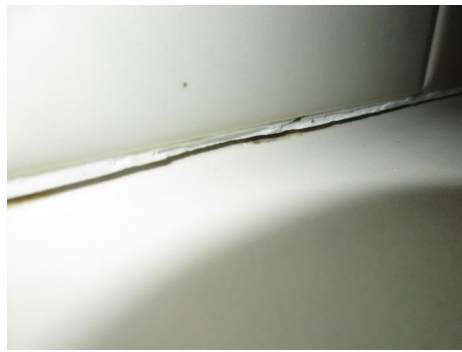
Seal

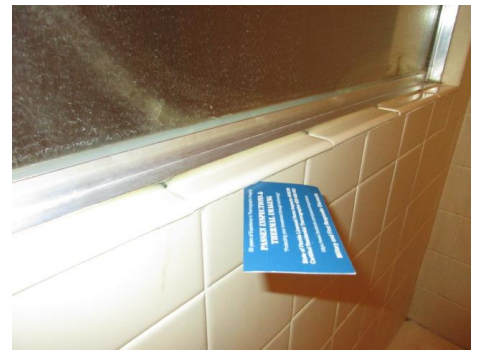
Seal, grout

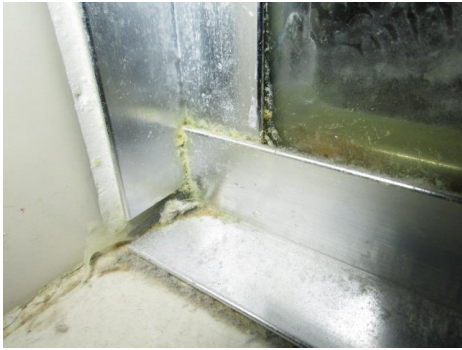
Evidence of moisture escaping shower at window

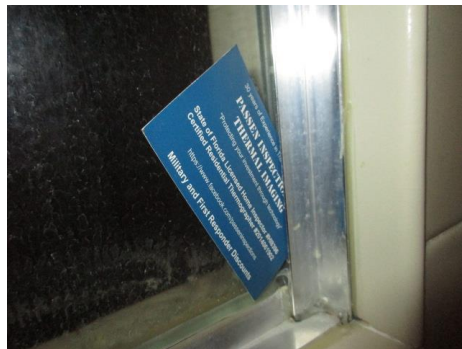
Opposite side

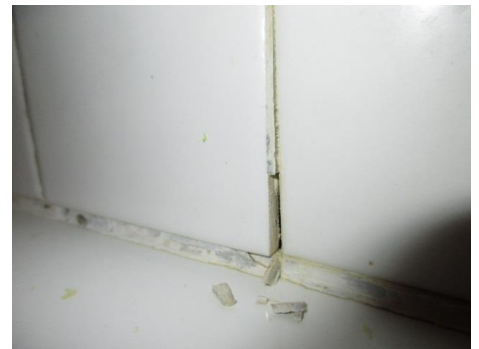
Loose, repair
