PASSEN INSPECTIONS AND THERMAL IMAGING

17750 E Lake Jem Rd, Mount Dora FL 32757
 352.530.7343 office 352.530.7361 cell
Infrared Thermal Imaging Report

Today's inspection date: December 20, 2014		Inspection time: 4:00pm
---	--	--------------------------------

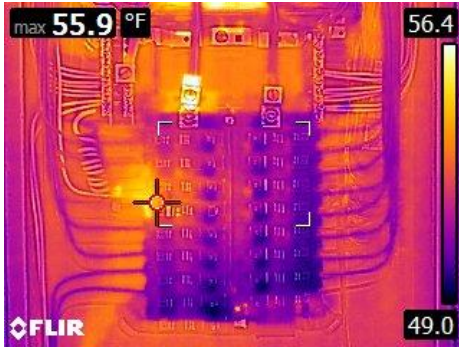
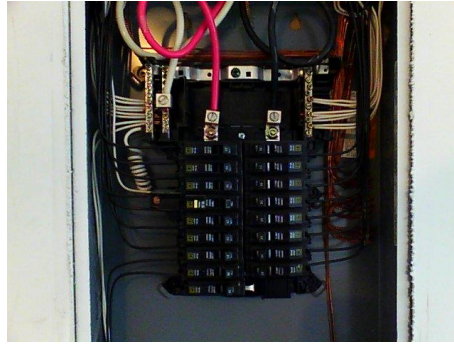
1.

- Thermal image 1 No current overheating conditions in sub panel.
- Thermal image 2 Heat leakage at duct work.
- Thermal image 3 Moisture at chimney in attic, verified wet with moisture meter.
- Thermal image 4 Moisture, upstairs ceiling at chimney, verified wet with moisture meter.
- Thermal image 5
- Thermal image 6
- Thermal image 7
