Report #: 6828

HOME INSPECTION REPORT FOR:

Maitland, FL 32751

DATE INSPECTED: November 20, 2015

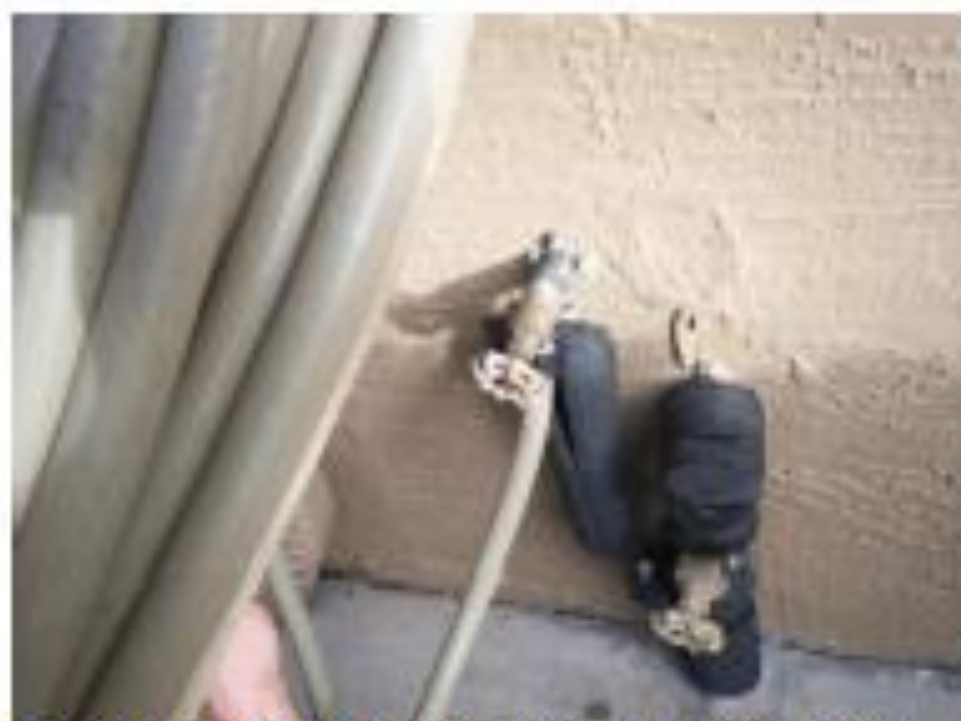
Most of the fixtures have shut off valves below. The main shut off for the water supply is located at right exterior of the garage. (See photo 1.)

Photo 1- The main water shut off at the right exterior of the garage.

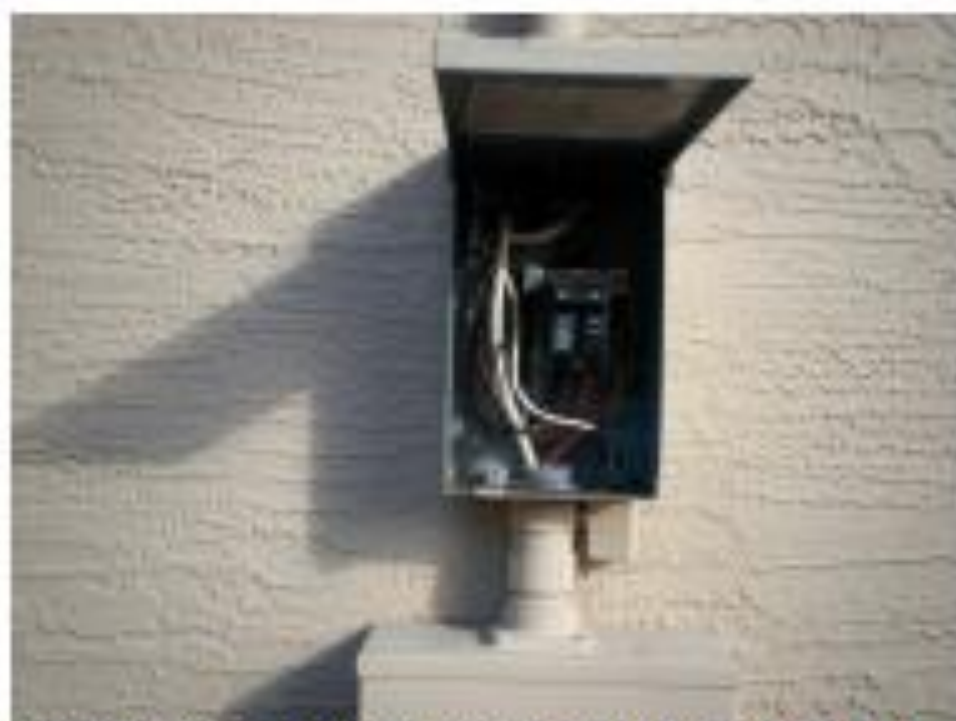
The main service into the home consisted of an underground, 120/240 volt feed, aluminum service entrance cables and a main disconnect rated at 125 amps. The disconnect was located adjacent to the meter on the right exterior wall of the house. (See photo 2.) The service was grounded on the exterior.

Photo 2- The Cutler Hammer Brand 125 amp main disconnect panel at the right exterior of the garage.

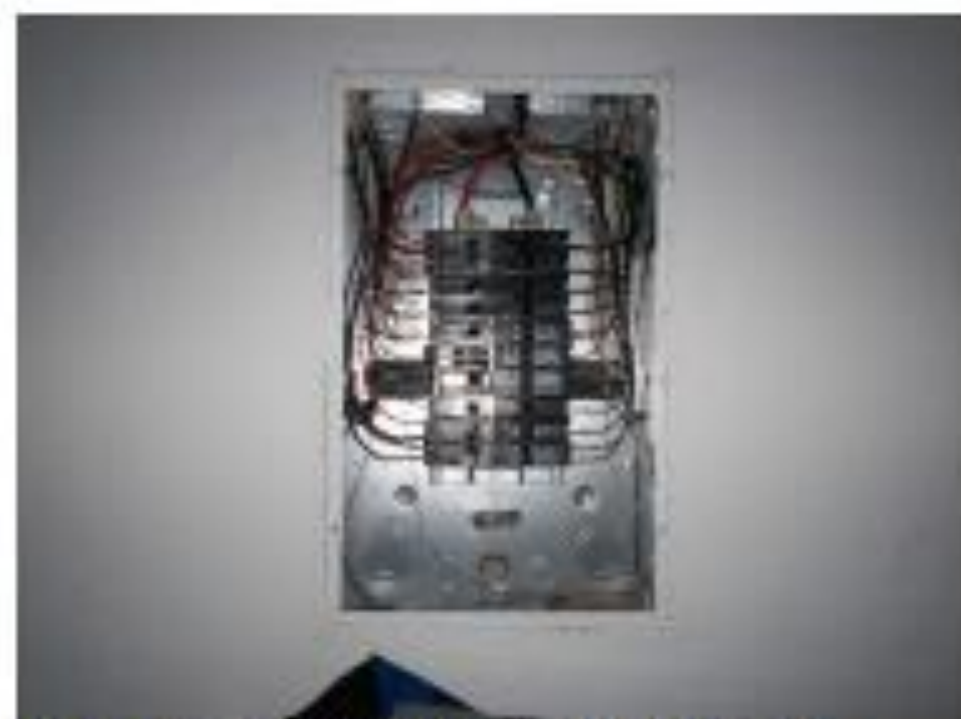
The distribution panel/breaker box was located in the . (See photo 3.) In this panel the breakers and corresponding lines were all properly sized and connected. There was room in the box for additional lines or breakers that may be required in the future.

Photo 3- The Cutler Hammer Brand distribution panel in the garage.

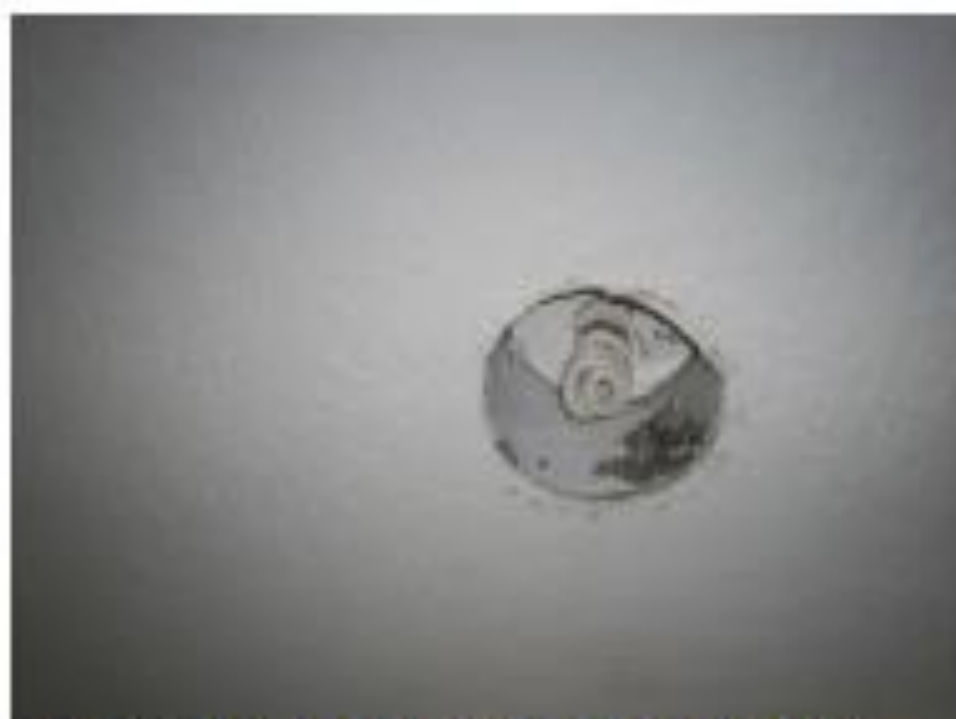
Miscellaneous photo of the unfinished light fixture in the second floor bath above the tub.
