**PASSEN INSPECTIONS AND
THERMAL IMAGING**

Inspection date: December 2, 2015 **Inspection time start/finish: /pm**

Requested for:	Inigo Montoya	Phone: 407.
Street:	XXXXXXXXXX Unit 151	Phone: 407.
City/Zip:	Maitland, Florida 32751	Email: @yahoo.com
Referred by or client of:		Phone: 407.
		Phone: 407.
		Email: .com

Inspections requested: Condo/Townhouse w/ exterior.

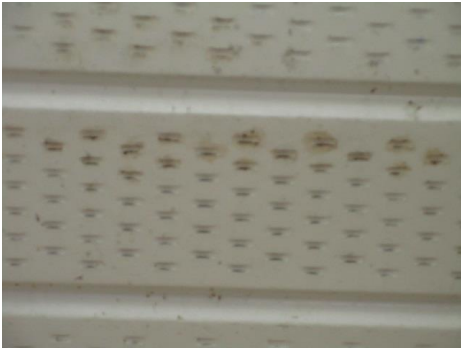
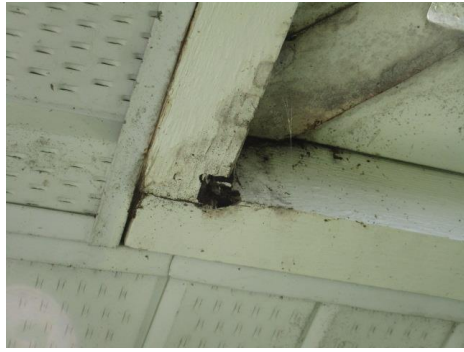
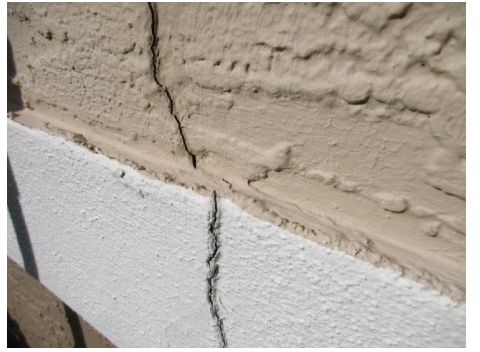
Component	Comment	Perspective
Grounds	It is always desirable to slope grade away from the house, always maintain for best performance of house. Remove bolts emerging from walkway, trip hazard.	Minor
Siding & Veneer	Cracks in your stucco type veneer are common. I currently do not see any that exhibit rotation or out of plane movement, however since Hurricane Jeanne and TS Fay, paint quality and shrinkage cracks issues have been amplified. It is very important to maintain all caulking and paint as this is a function of the building envelope. As a matter of fact, in ASTM 926 (standard for stucco application) A2.1.1 states that "Plaster shall not, however, be considered to be water proof." Other areas of concern include (but not limited to) light fixtures, windows/doors, penetrations, transitions, electrical panels, etc. See representative pictures of vulnerable areas. Moisture intrusion can lead to veneer damage and mold/mildew growth sometimes not visible. Exterior grout filler, silicone/urethane and/or double coat acrylic paint are recommended for veneer longevity and to inhibit moisture intrusion. The more detail caulking, sealing, painting and maintenance you do, the better the house will perform. There is always a possibility of latent/hidden defects from improperly installed vapor barriers, lathe and/or control joints. If you ever notice discoloration/damage, prompt inspection/repair is critical in reducing further damage. Large crack at half wall clod joint.	Maintenance

Fascia & Soffit	Moisture damaged fascia noted in corner near main entry door, repair. Corrosion in soffit near garage side entry door. Corrosion on metal soffits confirm chronic water intrusion. The soffit in this area appears to have had some repairs, see seller's disclosure.	Minor FYI
Trim	Appears serviceable. Any cracks/gaps at aesthetic stucco trim bands and/or corners should be monitored and maintained to prevent moisture penetration and subsequent lathe rusting and stucco spalling.	
Windows & Doors	Exterior window/door frame caulking needs to be monitored/maintained on a yearly basis to prevent gapping and subsequent moisture intrusion. Keep all window sill cracks sealed to inhibit interior rebar corrosion and sill damage. See also interior notes.	
Gutter System	Appears serviceable. We recommend all guttering systems have splash blocks and/or extension pipes to direct water away from foundation.

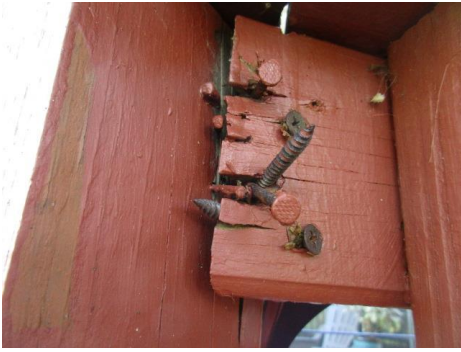
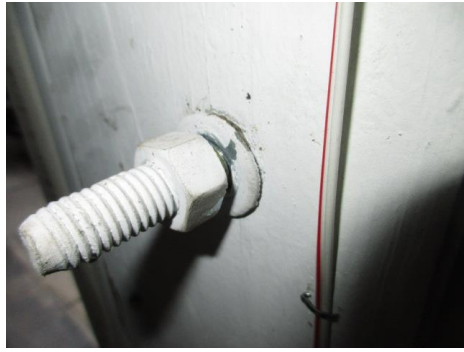
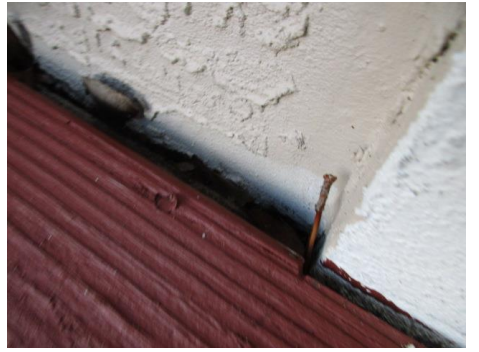
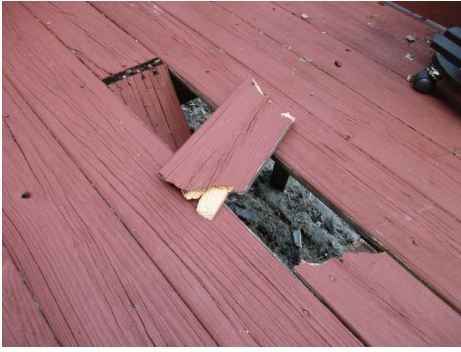
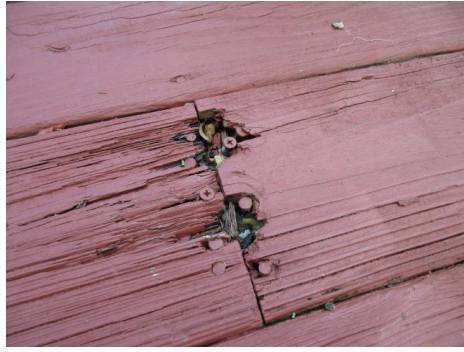
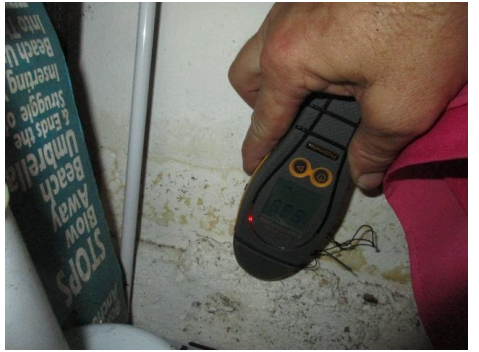
Component	Comment	Perspective
Garage is	attached, slab on grade.	
Construction is	concrete block. Several cold joint/stair step cracks. These are common and usually nothing to worry about. Monitor yours for any offset or rotational type movement.	
Floor is	concrete, appears serviceable but not fully visible due to stored items. Cracks in large concrete slabs are common and usually nothing to worry about. Monitor yours for any offset or rotational type movement.	
Ceiling is	drywall. Appears serviceable. Some previous repairs noted.	
Walls are	concrete block and drywall. Not fully visible due to stored items. Active moisture noted on garage wall. This same condition could exist elsewhere in the house but not visible because of drywall. See also exterior page, building envelope comments.	Minor
Garage Doors	Double torsion, metal. Loose buck bolts at garage door, check and secure all.	Minor
Door Openers	has operational auto reverse.

Door to Exterior	Appears serviceable.	
Windows	NA	
PORCH		
Type	Deck.	
Construction	Wood frame, post and beam. Pillar footings not visible. I recommend installing and sealing ledger flashing to inhibit surface tension moisture from migrating under the flashing via capillary action.	Minor
Flooring	Painted 5/4 decking has several soft spots and one large damaged area. Budget for full replacement of decking material. Keep in mind that some damages to the support structure may be found when the decking is removed.	Moderate
Built ins	These railings are an older standard which may be hazardous to small children. Safety upgrades are recommended if young children will be present. Several staves/connections are loose and others have been repaired with drywall screws. Some areas have had many repair attempts and the wood is broken away leaving no purchase for the fasteners. Future performance is doubtful. Recommend rebuilding these railings to the current safety standards using proper connectors/fasteners.	Safety Moderate

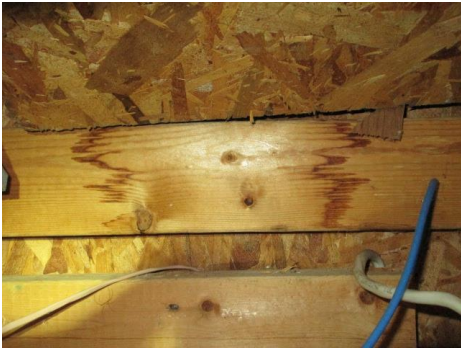
Component	Comment	Perspective
Access	Attic was entered but inspection was limited due to obstructions/physical size.	
Framing	Truss framing. Appears serviceable.	
Sheathing	Few leak evidences were found but since sheathing has a relatively high drying capacity, I cannot prove if these are old or active, see representative pictures and monitor immediately after a rain.	FYI to ?
Insulation	Appears serviceable. 6" fiberglass batts.	
Ventilation	Attic ventilation is from off ridge and soffit venting and appears serviceable.	
Dryer Vent	Not accessible.	
Bath Vents	Appear serviceable.	
Exposed Wiring	Appears serviceable	
Plumbing Vents	Appears serviceable.	
Skylights	NA	
Chimney	NA	
Crawl Space	NA

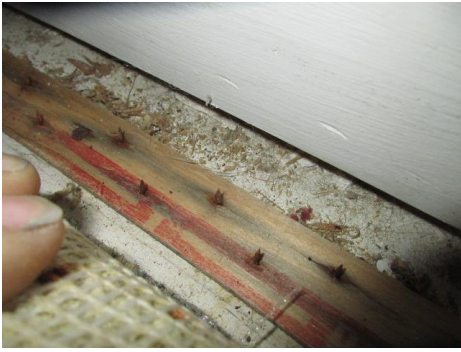
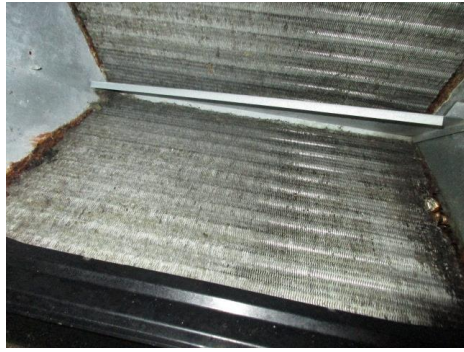
Component	Comment	Perspective
Type System	This home has electrically controlled 3ton split central systems. The condensing unit is located outside and the air handler is located in the interior closet. Seal line set penetrations on front of air handler cabinet to inhibit system from ingesting air/debris and bypassing filter. Float switch is recommended as an upgrade. This device shuts unit down in the event of a condensate line clog. Condensate line is partially visible and may require routine maintenance to prevent water back up. Previous overflow evidence.	Upgrade
Condition	Maintaining suction line insulation at condensing unit recommended for efficiency. The bottom side of the evaporator coil is soiled and should be cleaned. The filter is located at the return and is in acceptable condition. A filter upgrade is recommended for equipment protection and longevity. Fungal growth inside cabinets and ductwork is common. Many of these evidences may not be accessible or are outside the scope of a normal home inspection. The older a system is, the higher the probability the system needs a full cleaning/servicing. A yearly service and monthly filter change is recommended to maintain an efficiently running system.	Minor

Performance Statistics	Appears serviceable. Manually operated via thermostat. Supply/return temperature is 52/72. Normal temperature split (return temp - supply temp) is between 14 and 20 degrees, yours is currently 20. The current operating amperage/manufacturer's maximum amperage is 14.4/20.5. Due to the elevated ambient temperature today, we are unable to operate any system in the heating mode as it could damage the system. You may wish to have evaluated prior to closing.	
Life Expectancy	For comparison only, the statistical life expectancy of an AC compressor and furnace is 15-20 years. Your condensing and evaporative unit is 16/16 years old.	
Duct Work	Appears serviceable. Round flex and fiberglass duct board located in attic. Since air quality is beyond the scope of this inspection and the interior condition of your duct work is not visible or accessible, you may wish to conduct such quality tests and/or clean your ducts as a matter of environmental hygiene.

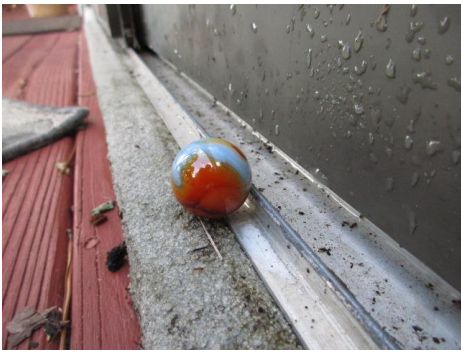
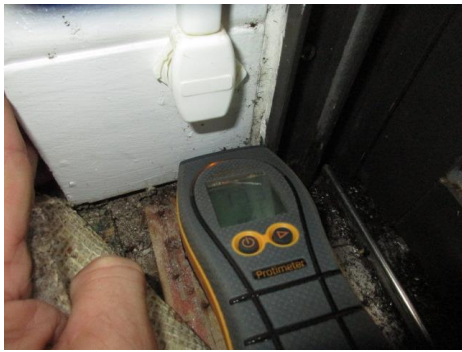
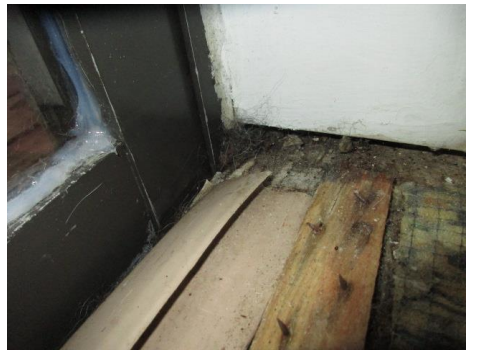
Component	Comment	Perspective
Walls, Ceiling & Floors	Drywall walls and ceiling. Appears serviceable, but not fully visible due to furniture and other items, fully furnished. An interior infrared scan was performed, see attached report.	
Doors & Windows	A representative sampling of windows was taken, screens are not normally checked. Never block windows with furniture as this could pose fire egress or ingress hazard. The rear sliders have chronic water intrusion at the base. Weep holes have recently been installed. A newer appearing exterior curb installed is slightly troughed. Recommend sealing all around the threshold from the exterior and monitor. Sliding door binds when opened, repair/adjust as necessary.	Minor
Fireplace	NA	
Smoke Detectors	Appear serviceable, units responded with manual test button, be sure to replace batteries yearly and units that are 10 years or older. We recommend replacing any existing ionization chamber types with photoelectric sensing ones. Ionization types have a much higher failure rate and may not sense smoke from smoldering fires or smoke from synthetic materials. Smoke detectors, fire extinguishers, emergency lighting and other fire/emergency equipment requires a different State license to evaluate. Consult proper professional for evaluations and certifications.

Stairs & Railings	Appears serviceable, 3 way lighting ok. Newer safety standards require stairwell hand rails to return to the wall or newell post, upgrades available.	Upgrade
Ceiling Fans	Appears serviceable. We do not necessarily operate every fan on high and check for wobble.	
Laundry area	Washer/dryer were in use during inspection.	
Cabinetry & Shelving	Appears serviceable.	
Dryer Exhaust	Recommend metallic type vent pipe as upgrade as plastic/mylar ones can catch fire.	Safety
Laundry Sink	NA	
Plumbing	Appears serviceable. Most hoses are only designed to last 5 years. Always monitor your hoses for bulges and replace immediately. I recommend upgrade to Floodchek hoses (www.floodchek.com), see attachment.

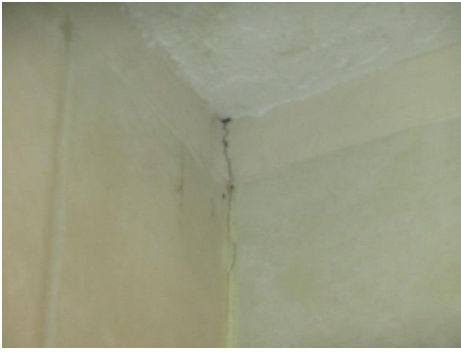
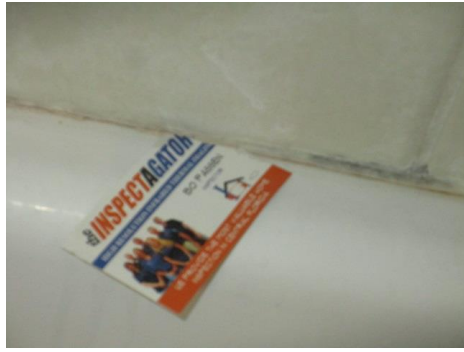
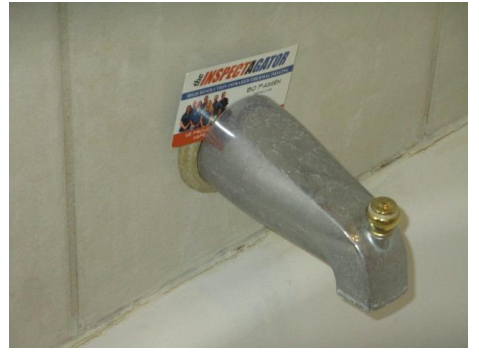
Component	Comment	Perspective
Walls, Ceilings & Floors	Appears serviceable. Drywall walls and ceiling. Tile floors. Walls behind and around toilets check dry on moisture meter.	
Doors, Windows & Ventilation	Appears serviceable.	
Cabinetry	Appears serviceable.	
Sinks	Appears serviceable.	
Toilets	Toilets loose at floor, down hall bath and up bath, secure and seal to inhibit wax ring damage. Elevated moisture readings around base of dawn hall toilet.	Minor
Tubs	Tub shell has been repaired, monitor.	Maintenance
Showers	The presence, requirement and/or enforcement of a shower pan is unknown. All grout lines, hairline cracks, hardware penetrations, transitions, escutcheons, tub spouts and joints must be maintained to inhibit unseen moisture penetration behind the tile. Replace cover over light in up shower.	Minor
Tile Work	Elevated moisture found behind up shower tile walls. This is a common occurrence. As grout lines shrink, water wicks in hairline cracks and gets behind the tile. There are currently no disbonding tiles or soft walls, we recommend that grout lines, cracks, gaps, etc. be resealed and maintained. Interior wall conditions unknown. Home improvement stores sell a grout sealing kit that will seal grout line cracks prevent moisture intrusion behind the tile. Corners, larger grout line cracks or gaps should be caulked.	Minor
